# ***Etchells Fleet 27***

## **RUST STAINS FROM WATER LEAKING AROUND CHAINPLATES**

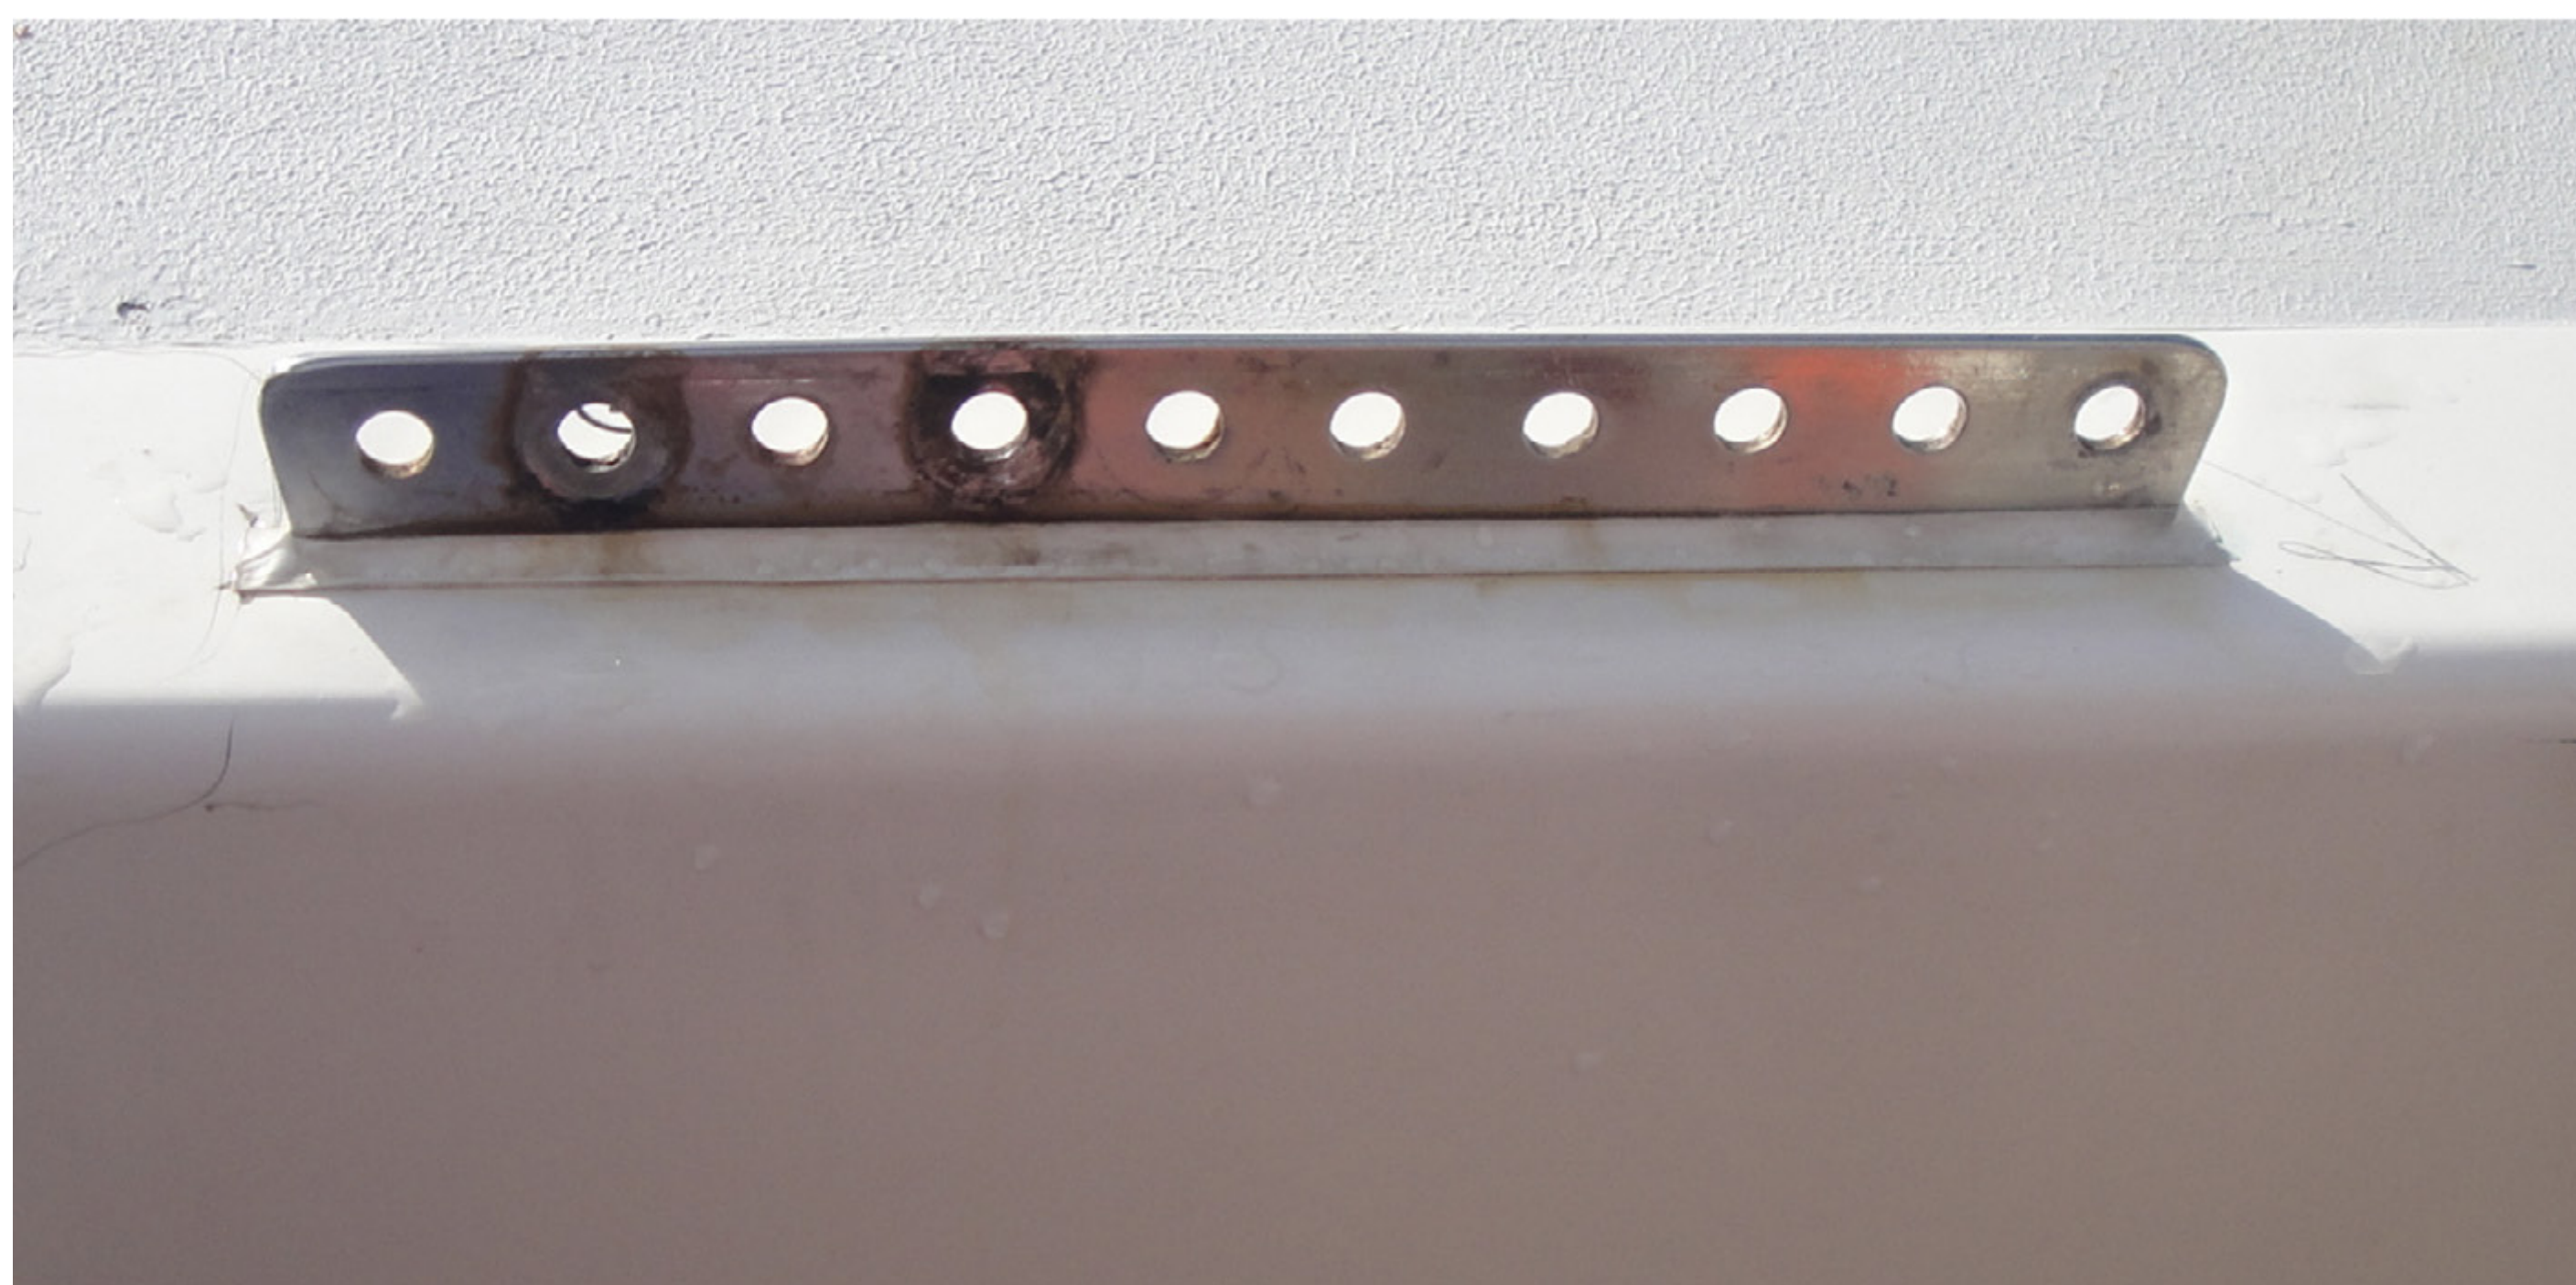
Do you get rust stains inside the hull in the area where the chain plates attach? It is likely due to water entering through the joint where the chain plates pass through the deck.

**Marine Silicone Sealant applied around Chainplates – this one is ready to be resealed.**

I use white marine silicone seal to seal the joint. I think resin is too stiff, and not nearly strong enough, to seal that joint.

Clean out the joint with a small tool. Just clean out the loose stuff; don't go very deep. Then clean the surfaces with acetone.

Then tape around the chainplate and the deck. Maybe 1/4 inch from joint. That way you can build up a nice neat fillet of sealant without getting it all over the place. Use your finger or a popsicle stick to shape the fillet. Pull off the tape before the sealant sets up. The tape will leave a little “edge” around the perimeter of the sealant. That is good.

You will probably need to redo this every couple years. #
